Barangaroo Metro Station

Tree Report

N217 BR COP 13 September 2022

Arboricultural Impact Assessment

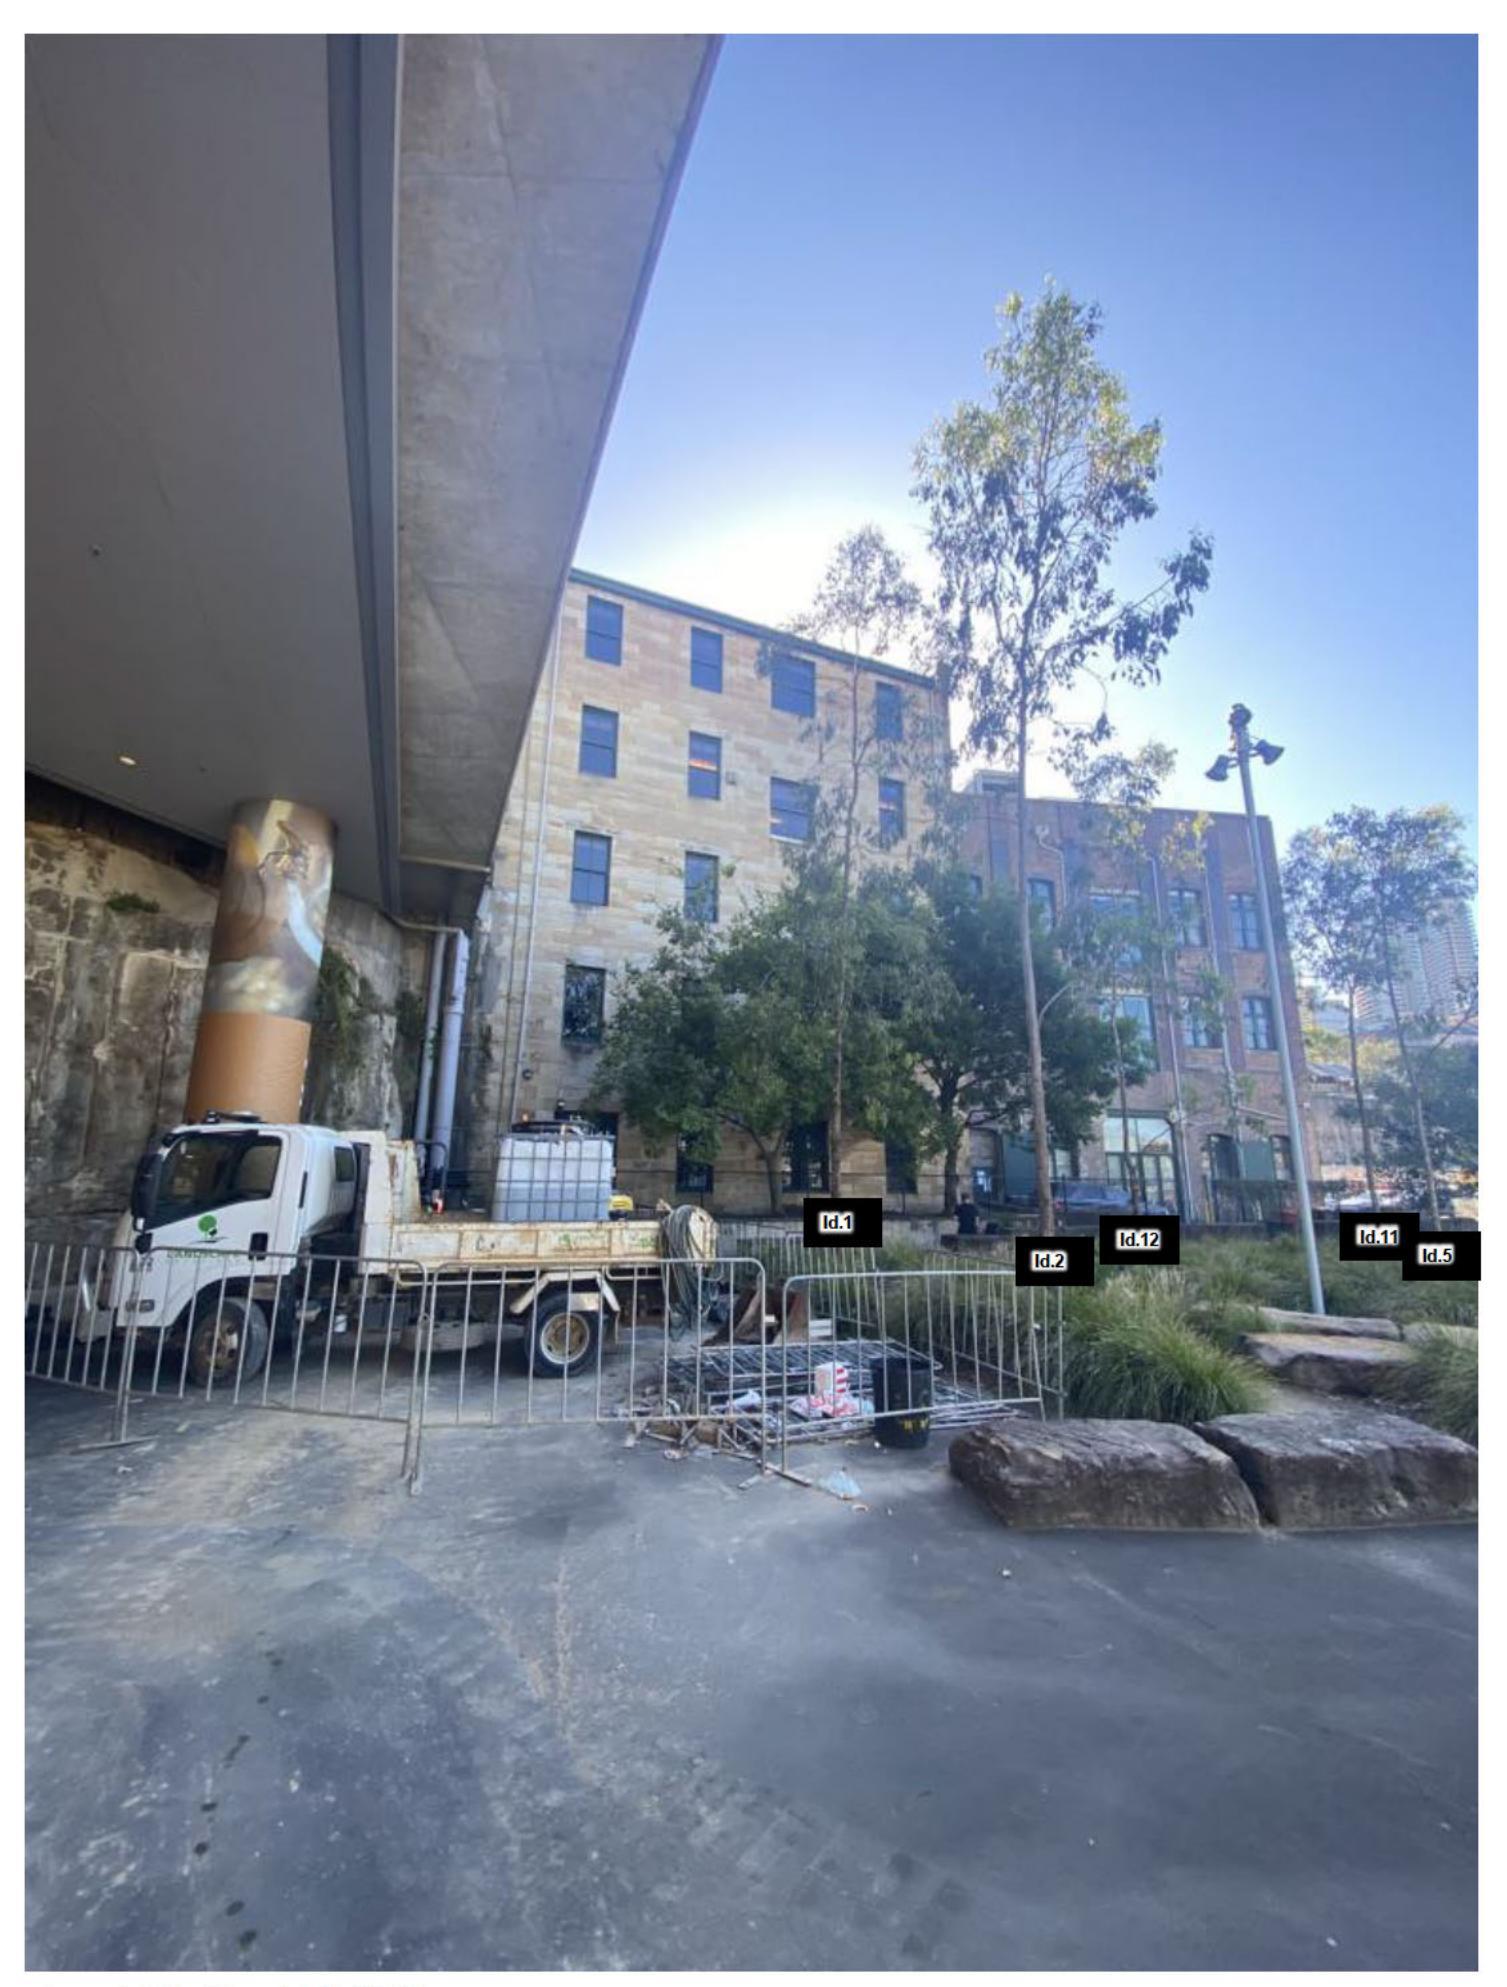
Image 1: Subject Trees 1, 2, 5, 11 & 12

Existing Storm Water Pipe to be Demolished and Reinstated: Subject Trees **id. 1 & 12** are located wholly within the footprint of the existing storm water pipe alignment to be demolished and reinstated and/or associated 1 m disturbance buffer. Excavations required will result in a major encroachment (>20%) of the TPZ and are likely to have a significant impact on the Subject Trees' ability to store carbohydrates, use stored carbohydrates in times of stress and are likely to have a significant impact on the health, condition and/or stability of the Subject Trees long term.

Condensed Water Pipe Alignment: Subject Trees **id. 2, 5 & 8-11** are located wholly within the footprint of the condensed water pipe alignment and/or associated 1 m disturbance buffer. Excavations required will result in a major encroachment (>20%) of the TPZ and are likely to have a significant impact on the Subject Trees' ability to store carbohydrates, use stored carbohydrates in times of stress and are likely to have a significant impact on the health, condition and/or stability of the Subject Trees long term.

Total Impact: Subject Trees **id. 1-12** are located wholly within the construction footprint 1 m disturbance buffer and/or plant movement and materials storage area and are recommended for removal as part of the proposed development.
