Barangaroo Station

Heritage Management Sub Plan

N217
BR COP
11 January 2024

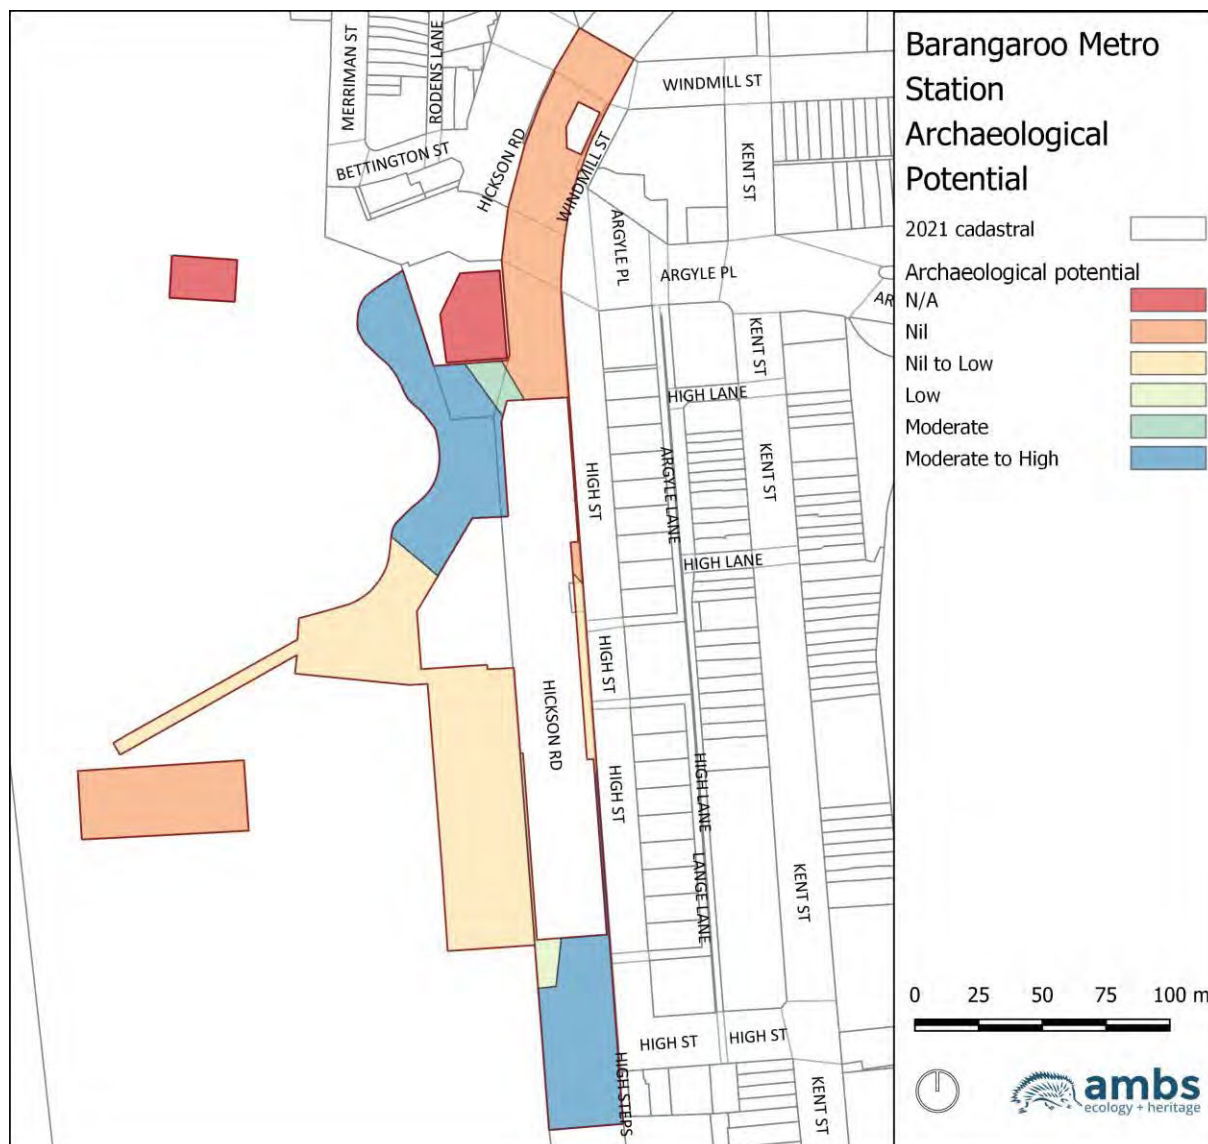
Figure 6.1: Areas of historical archaeological potential at the Barangaroo COP site.

Archaeological testing will be undertaken in areas of Moderate-high potential to establish the depth of archaeology and to confirm its integrity in those areas. If it is found that the impacts will exceed the depths of the top of the nineteenth century archaeology, then open area stratigraphic excavation would proceed to salvage all archaeological remains within areas of impact. The testing will be directed by Mike Hincks, primary excavation director for the project.

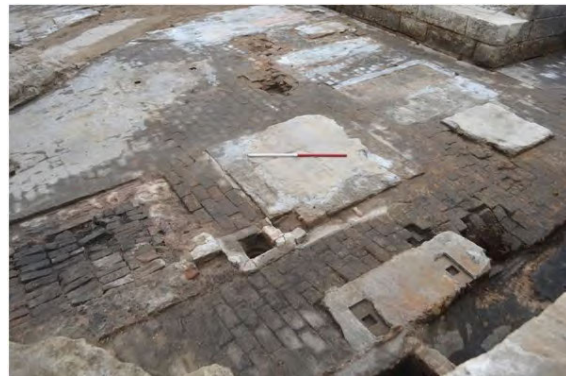
Figure 3.6: Foundations and floors of late nineteenth century wharf structures, Area Z (Casey & Lowe, 2019, p. 43)

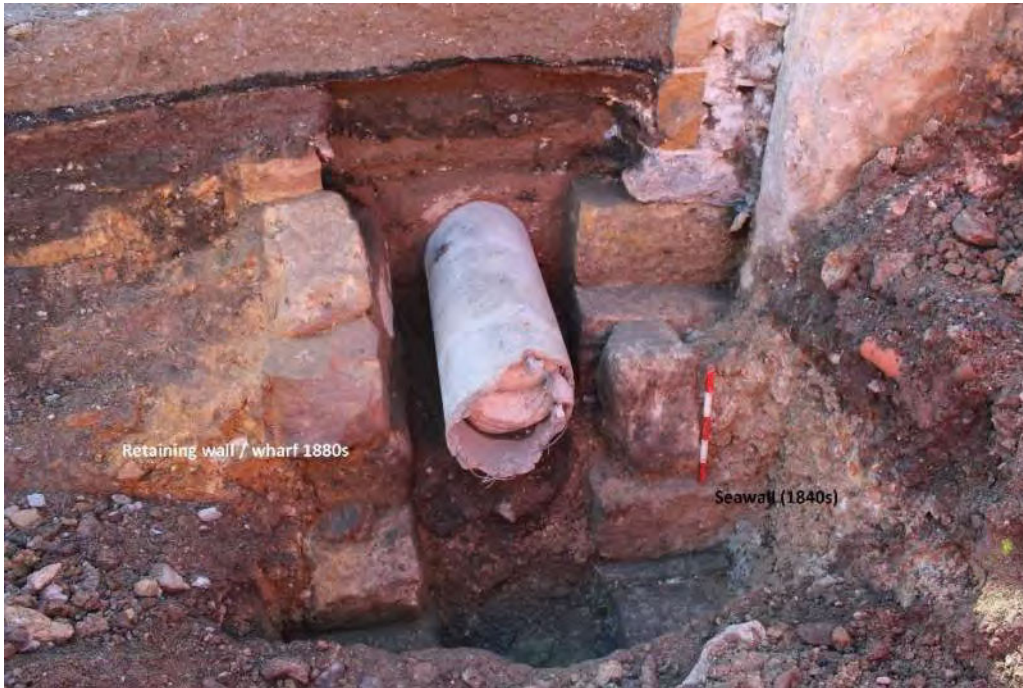
Photo 3 1840s seawall and 1880s retaining wall uncovered at Balmain East, 2016

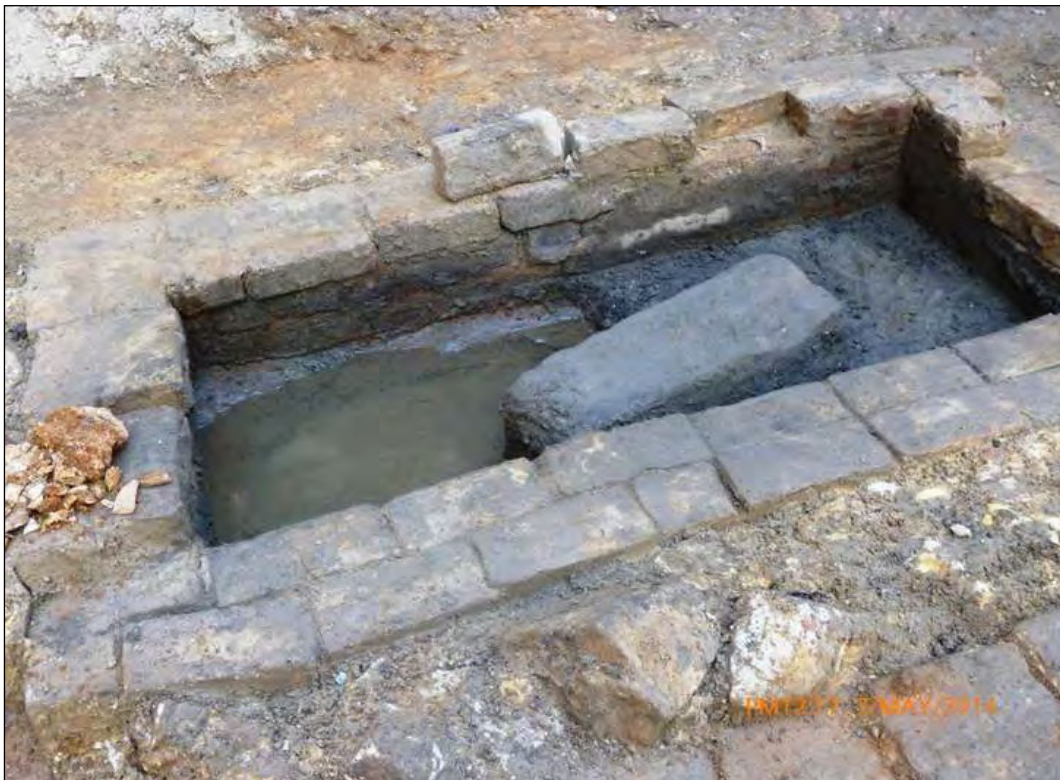
Photo 7 - Sandstone flagging and cesspit - Wynyard Walk project, 2014

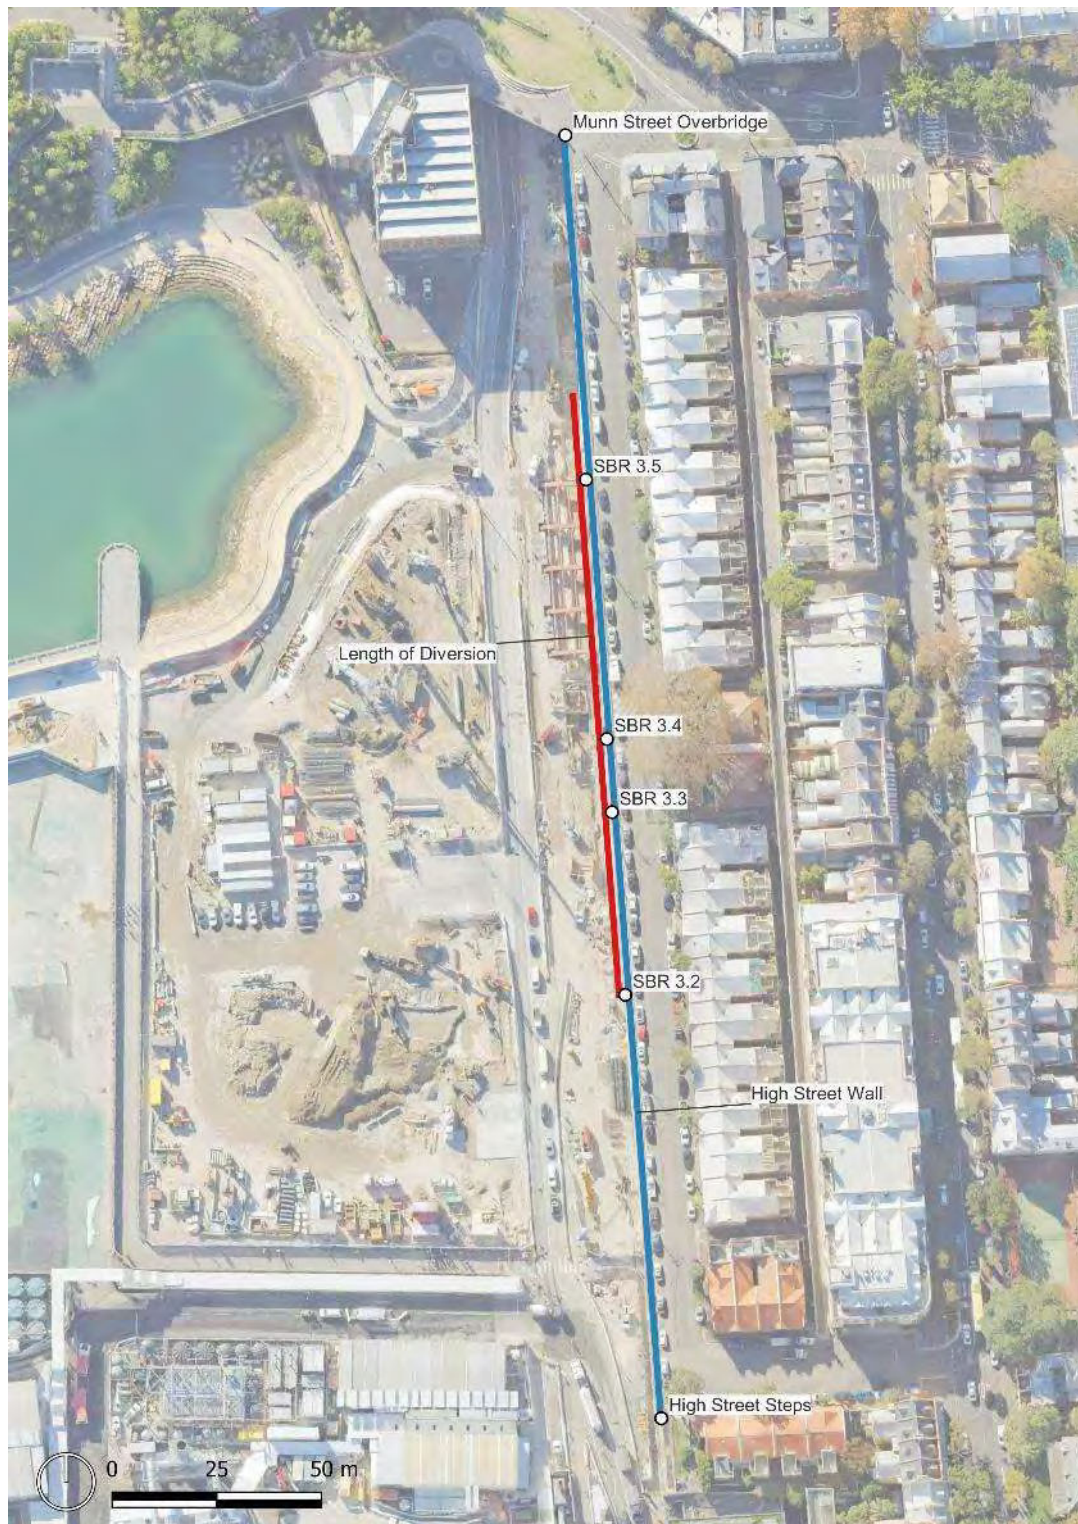
Figure 1: Location of the High Street wall, downpipes (SBR) and length of the diversion.

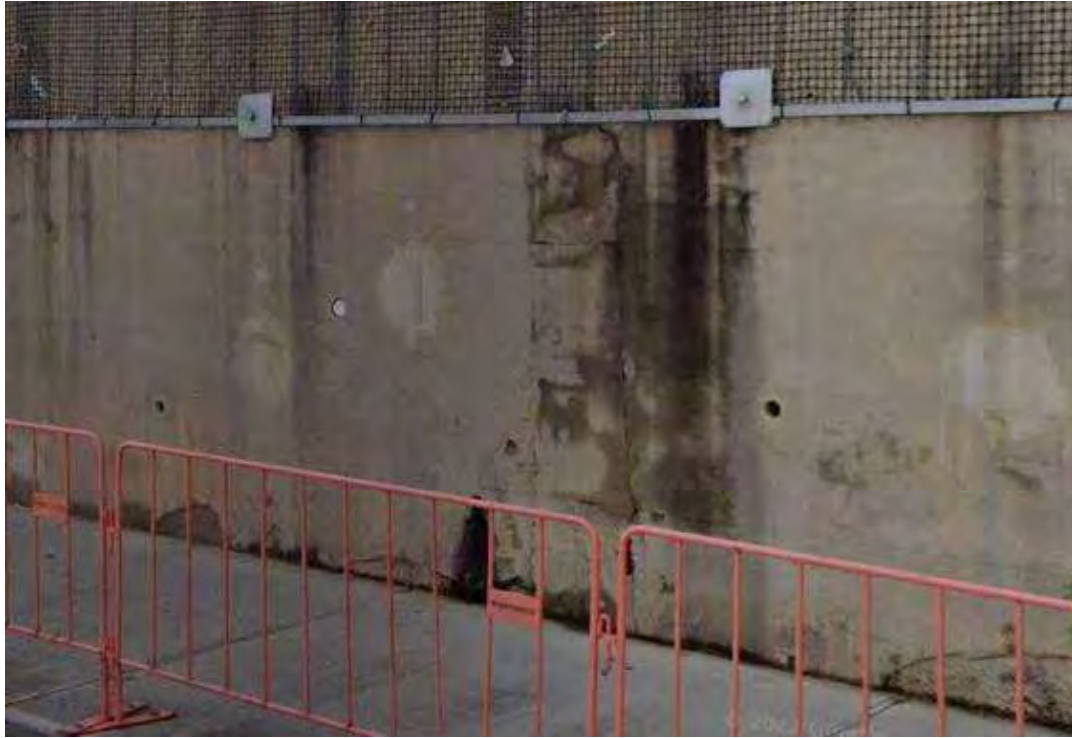
Figure 7: Cracking at the location of SBR 3.2.

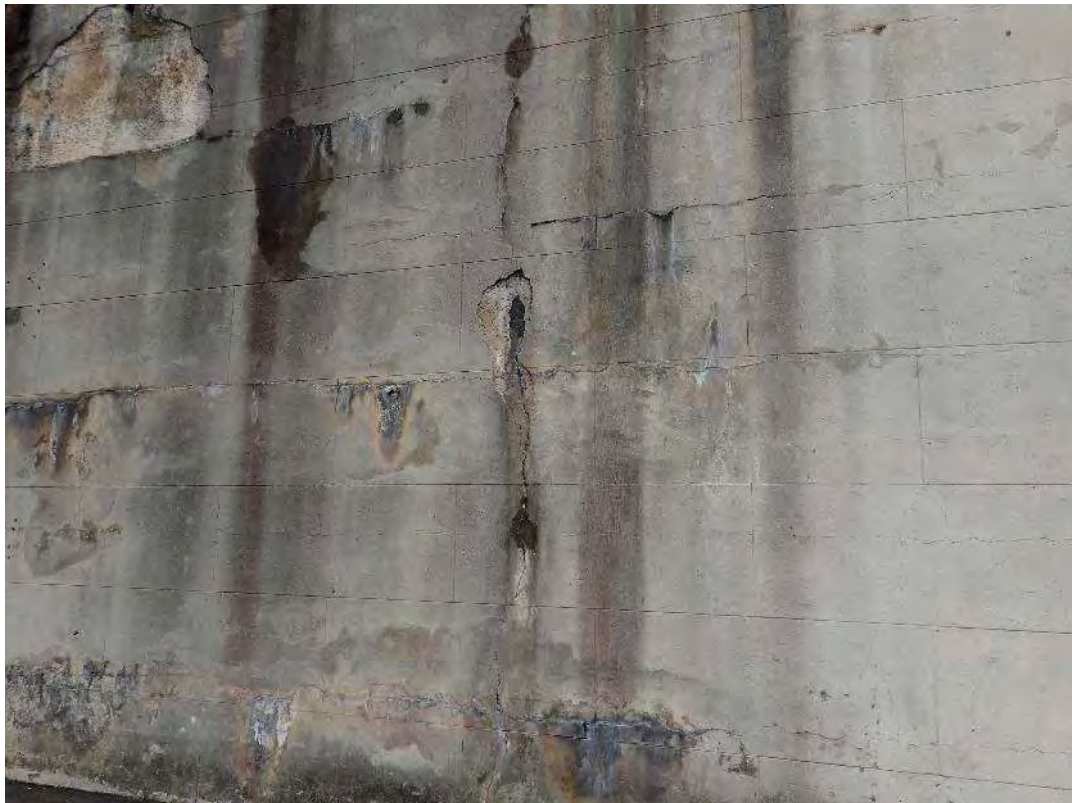
Figure 8: Cracks in the render at the location of SBR 3.3 (prior to the installation of the protective mesh).

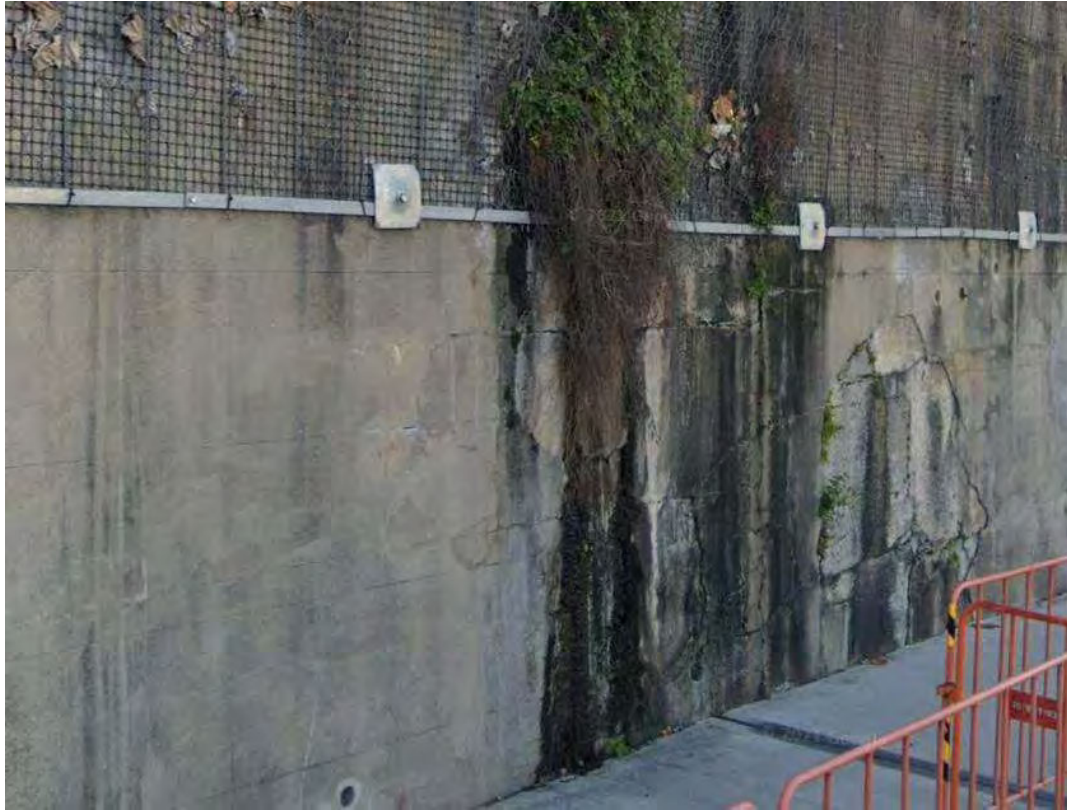
Figure 9: Cracking and intrusive vegetation at the location of SBR 3.4.

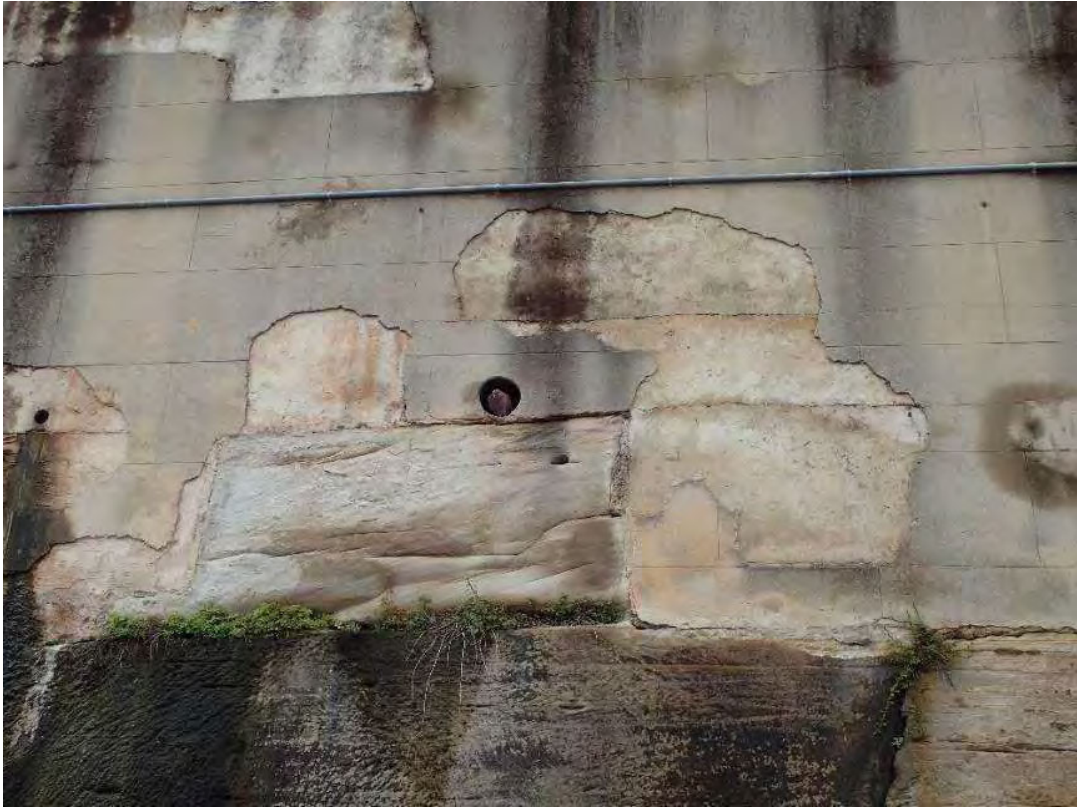
Figure 11: A section of the cutting and wall. The render is scored to replicate masonry blocks and is aligned along the line of the natural bedrock, above which the underlying sandstone blocks have been exposed.

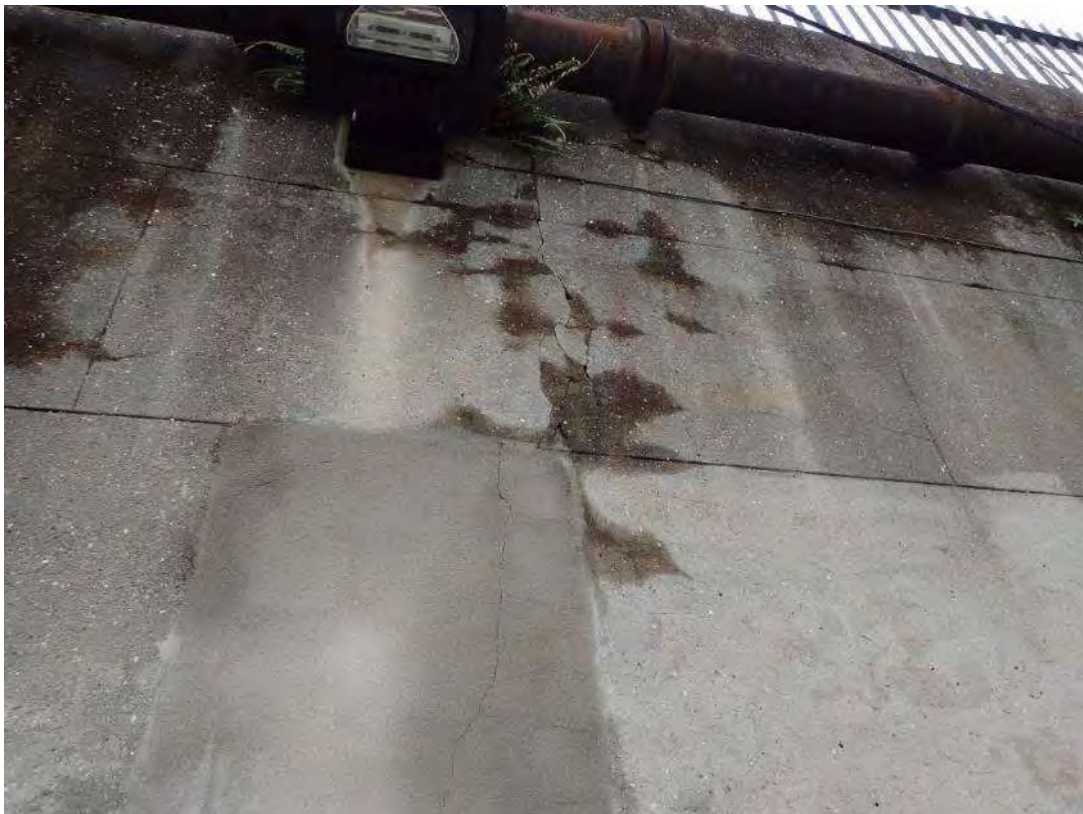
Figure 12: A patch of modern cement render surrounded by the original render. The white flecks are shell fragments.

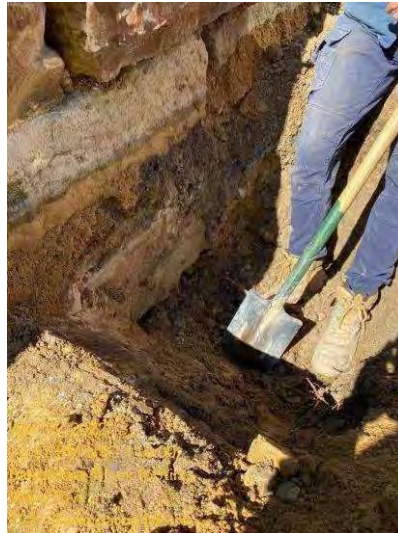
Figure 4: Concrete footing beneath sandstone blocks

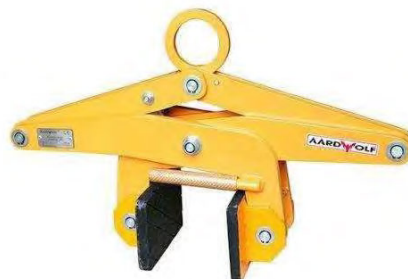
Figure 5: Rubber padded grab attachment

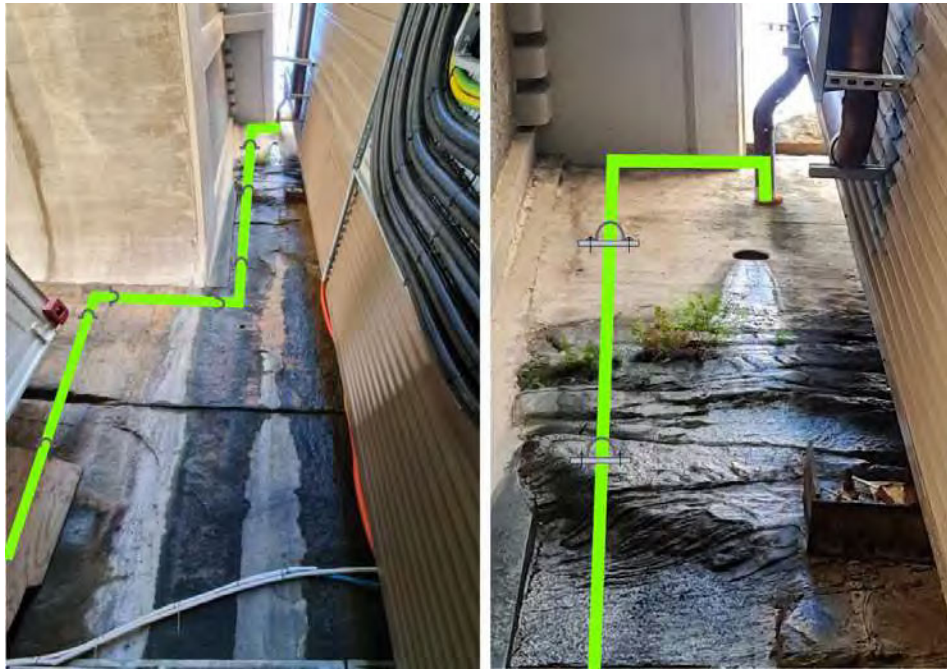
Figure 3: Illustration of the diversion.
